FIELD INVESTIGATION TEAM ACTIVITIES AT
UNCONTROLLED HAZARDOUS SUBSTANCES
FACILITIES — ZONE I

FINAL SITE INSPECTION REPORT
AIRCRAFT PAINTING, INC.
MILLVILLE, NEW JERSEY

OCTOBER 31, 1989

SITE NAME: Aircraft Painting, Inc.
ADDRESS: Millville Municipal Airport
Millville, New Jersey 08332

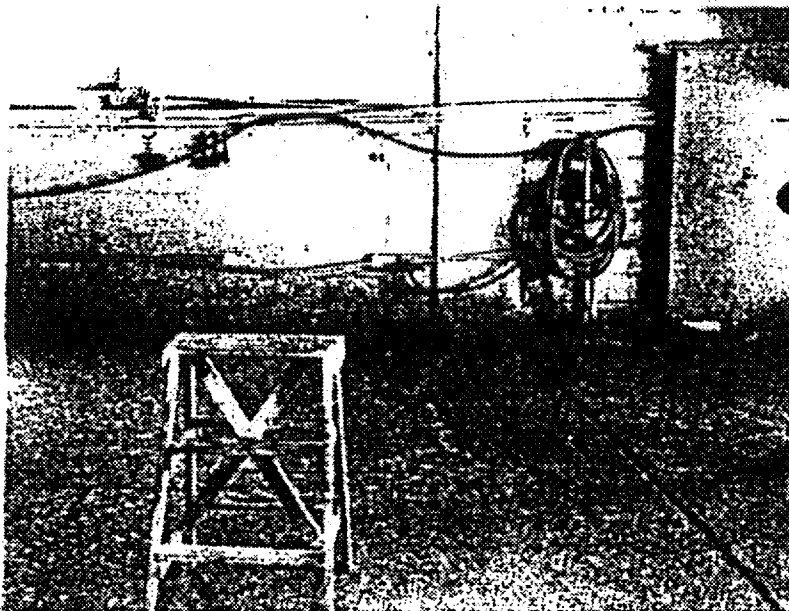
IP-19

East wall of the Aircraft Painting, Inc. hangar, showing the location of one of the plugged floor drains (within the darkened area to the right of the step ladder), approximately 15 to 20 feet from the hangar

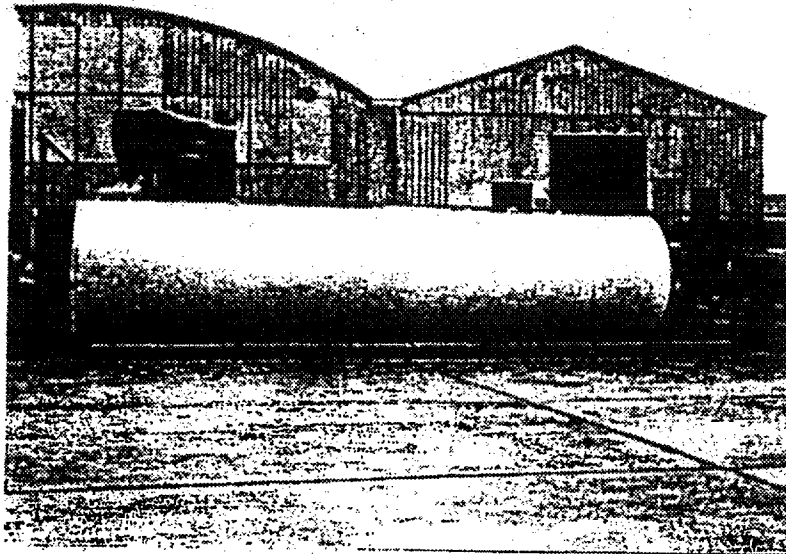
IP-11

The main waste source on site is a 4000-gallon aboveground steel tank located approximately 50 feet south of the Aircraft Painting, Inc. hangar along the east property boundary. The tank is used to store the chlorinated solvent wash waters generated by the paint stripping process. The tank is held in place by metal brackets underneath it, elevating the tank several inches above the concrete pavement. There are four 2-inch-diameter openings on the top of the tank which allow for evaporation of its contents. Because the tank is situated on a slight incline, the south end of the tank is slightly lower than the north end. There is no liner underneath the tank, nor are there any containment or diversion structures surrounding it.

Storage tank into which solvent wash waters are pumped, located along the east side of the site, approximately 50 feet south of the hangar.

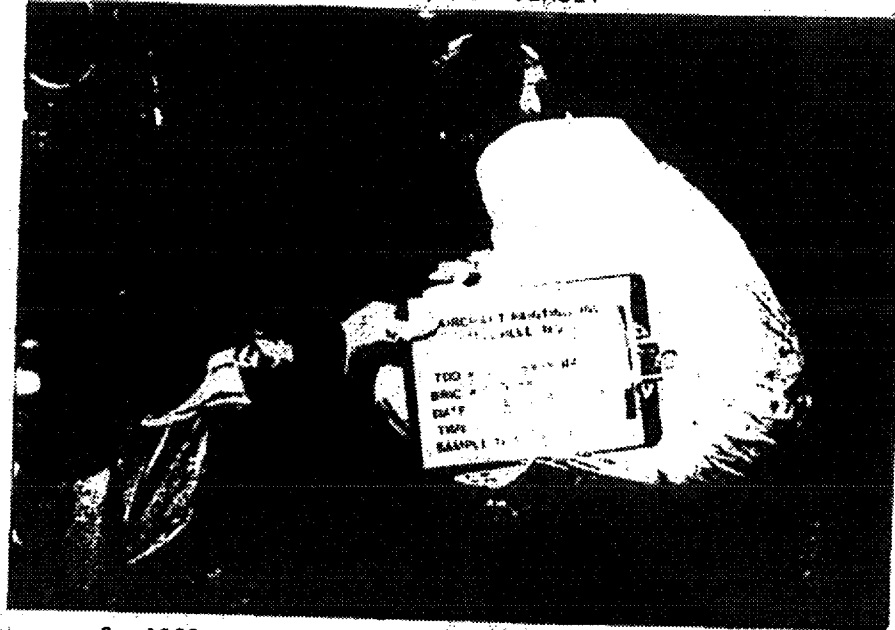
1P-1

August 2, 1988 0905
Kurt Fendler collecting surface water sample NJ88-SW1 from the downstream sample location in the drainage ditch into which the storm drain empties.

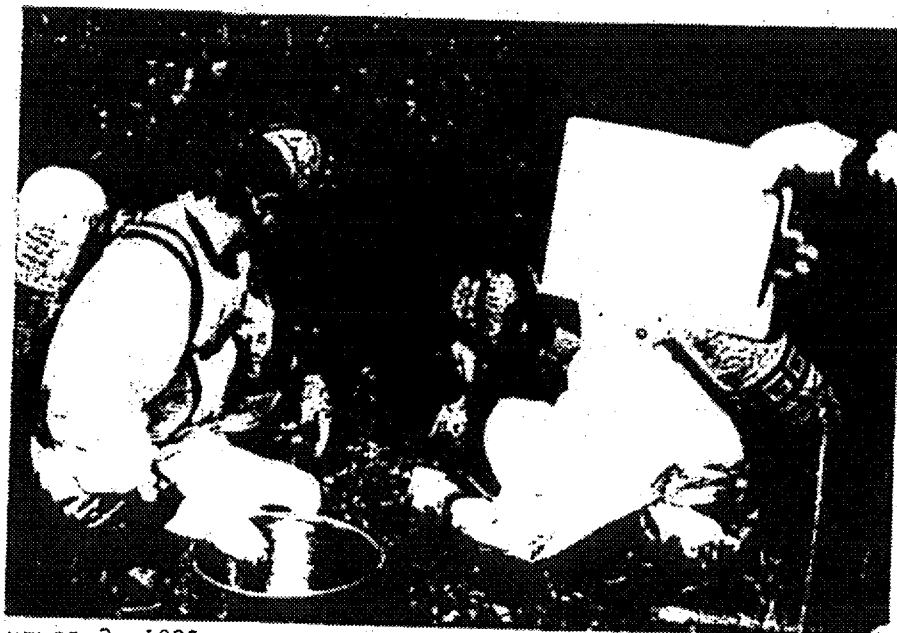
1P-2

August 2, 1988 1010
Kurt Fendler collecting sediment sample NJ88-SED1 from the same downstream location as NJ88-SW1.

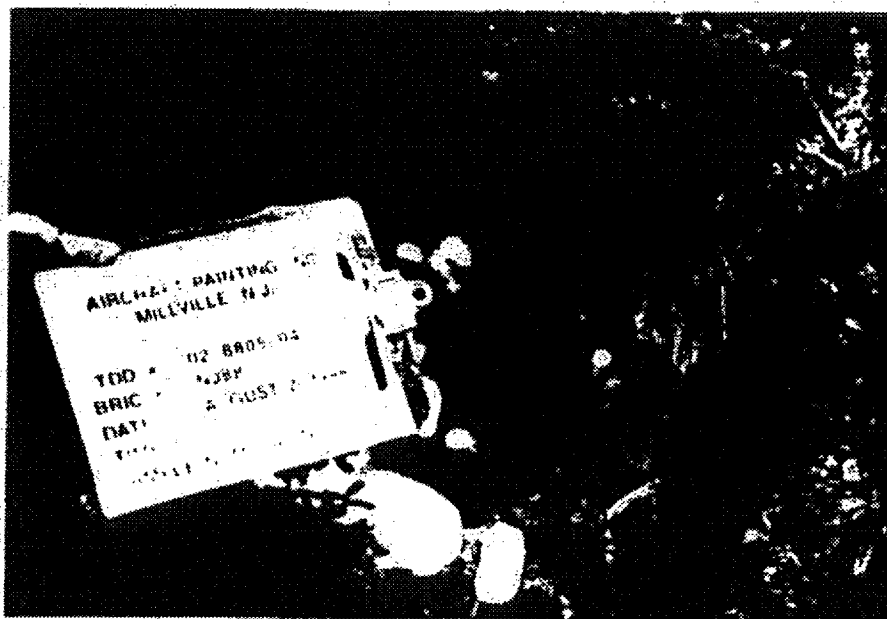
IP-4

Phil Solinski collecting surface water sample NJ88-SW3 from the same upstream location in the drainage ditch as NJ88-SW2 (SW3 is the environmental duplicate of SW2).

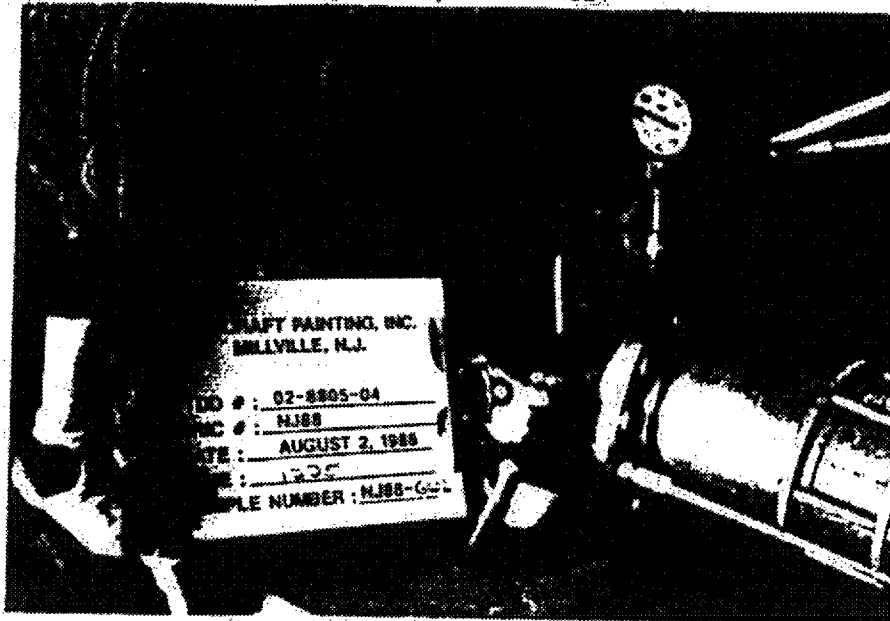
IP-7

August 2, 1988 1225
Chris Casiere collecting downgradient groundwater tap sample NJ88-GW2
from Millville public supply well Airport No. 3.

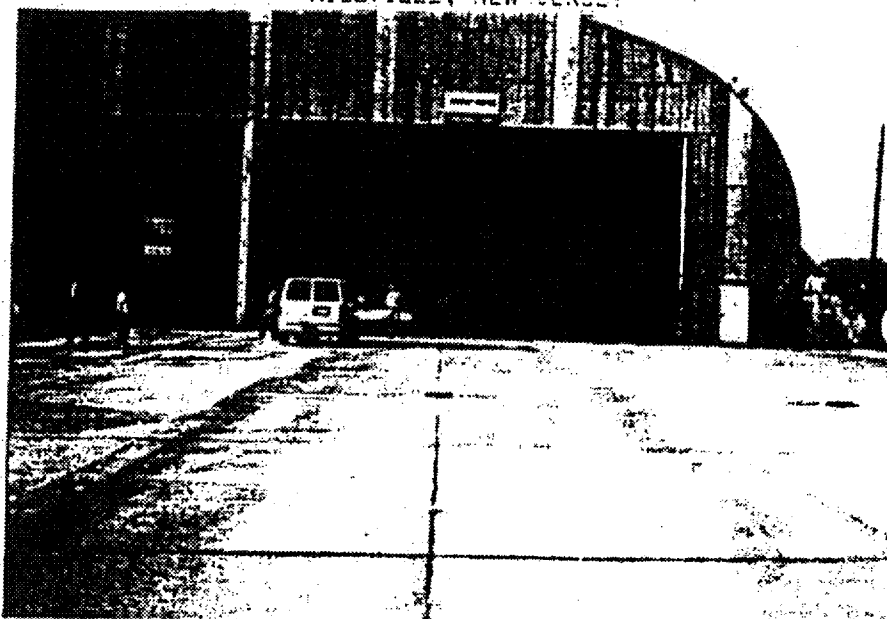
IP-10

It was noted during the site inspection that the concrete pavement between the Aircraft Painting, Inc. hangar and the storm drain was stained a grayish-green color. No sample was collected from the storm drain, however, as there was an insufficient quantity of water in the drain.

View of the discolored sloping pavement between the Aircraft Painting, Inc. hangar and the storm drain. Photo was taken while standing at the storm drain, facing north.
